Technical Service Bulletin

TSB # - 00018_R1
Date - 08/10/16

- Replacement of SC ECU (P/N 6500073) with Omex ECU (P/N 6500045)

- Commando 961 Dual Seat only, manufactured between Mid 2012 and Dec 2015

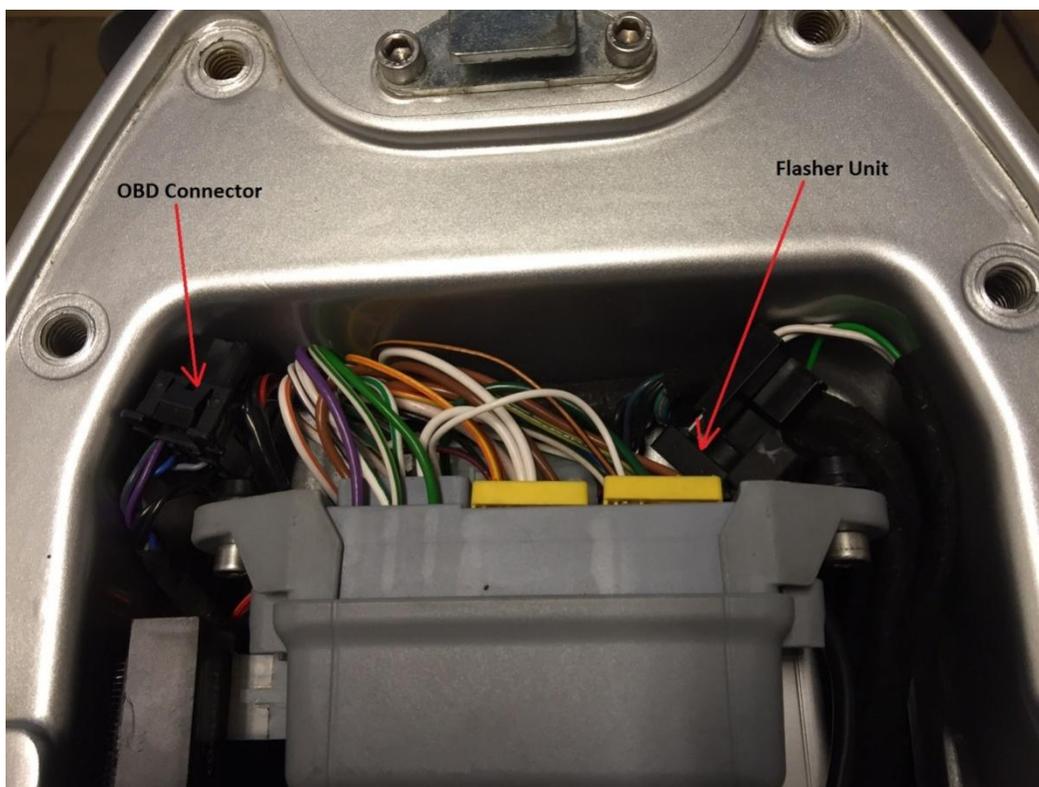
******* WARNING : OBD PORT CONTAINS LIVE WIRE TO BATTERY 12V TERMINAL, IF DISCONNECTED ENSURE WIRE IS PROPERLY INSULATED. *******

4. Disconnect SC ECU (P/N 6500073) from harness by gently levering up locking tab on the connector. SC ECU no longer required (please return to Norton Motorcycles UK)
5. Replace large indicator flasher unit with smaller unit (P/N 6500065) , place smaller unit in L/H rear corner of the tail unit. Also relocate OBD port to R/H rear corner of the tail unit. The OBD port is now redundant and the large indicator flasher unit is also no longer required.
