Eliminating oil leaks due to pressure build up in the Commando gearbox

by Fred Eaton

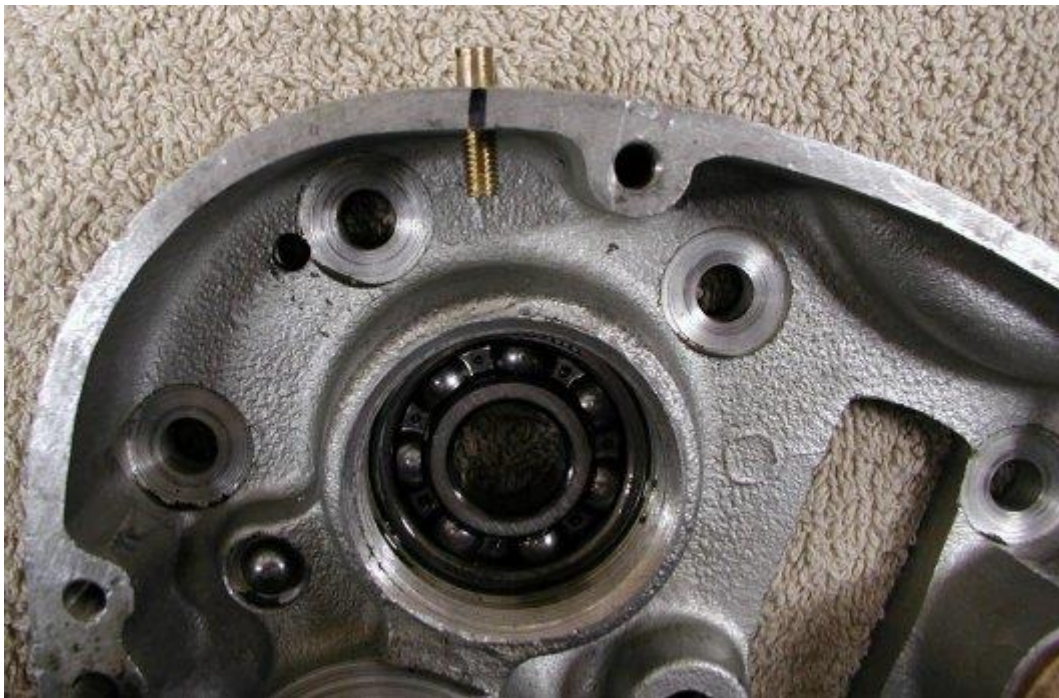
A picture of the breather installed on the inner gearbox case.

The best way to fix the pressure build-up is to install the MK3 breather vent (06-5199). This can easily be done with a #21 drill and a 10 x 32 tap. Drill a #21 hole, in the position shown in the next picture, .8" from the stud hole and 3/8" in from the edge. Tap this hole with a 10 x 32 tap and thread in the breather vent.

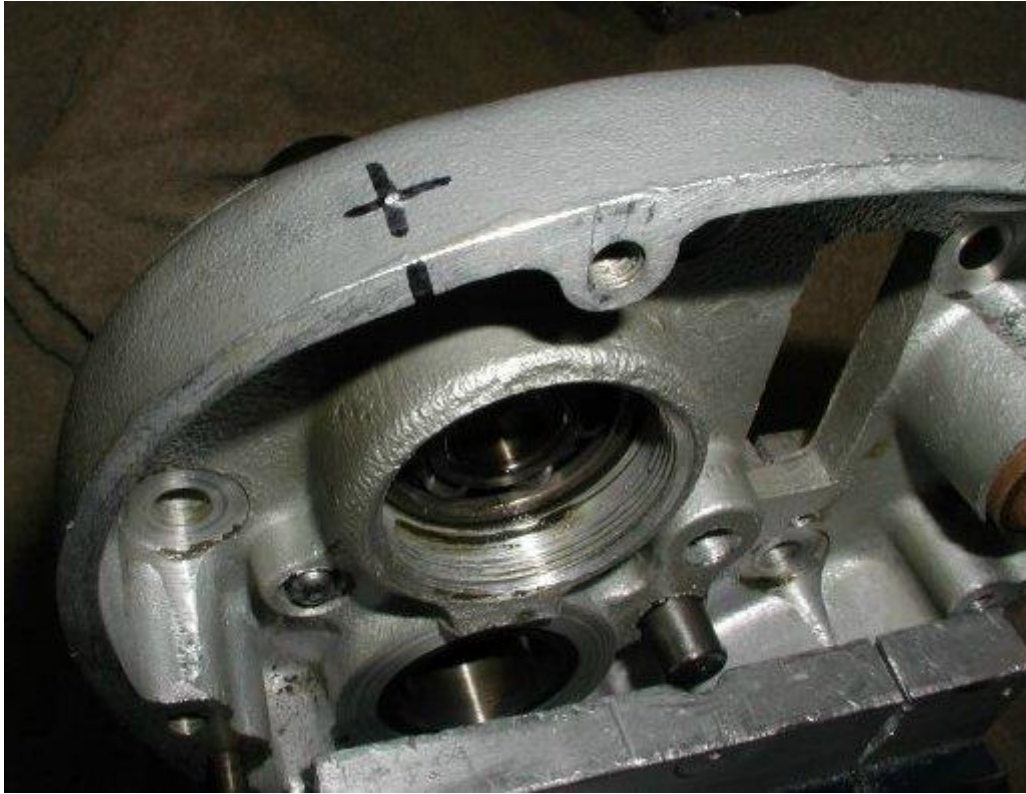
The inner case marked and punched where the hole is to be drilled.

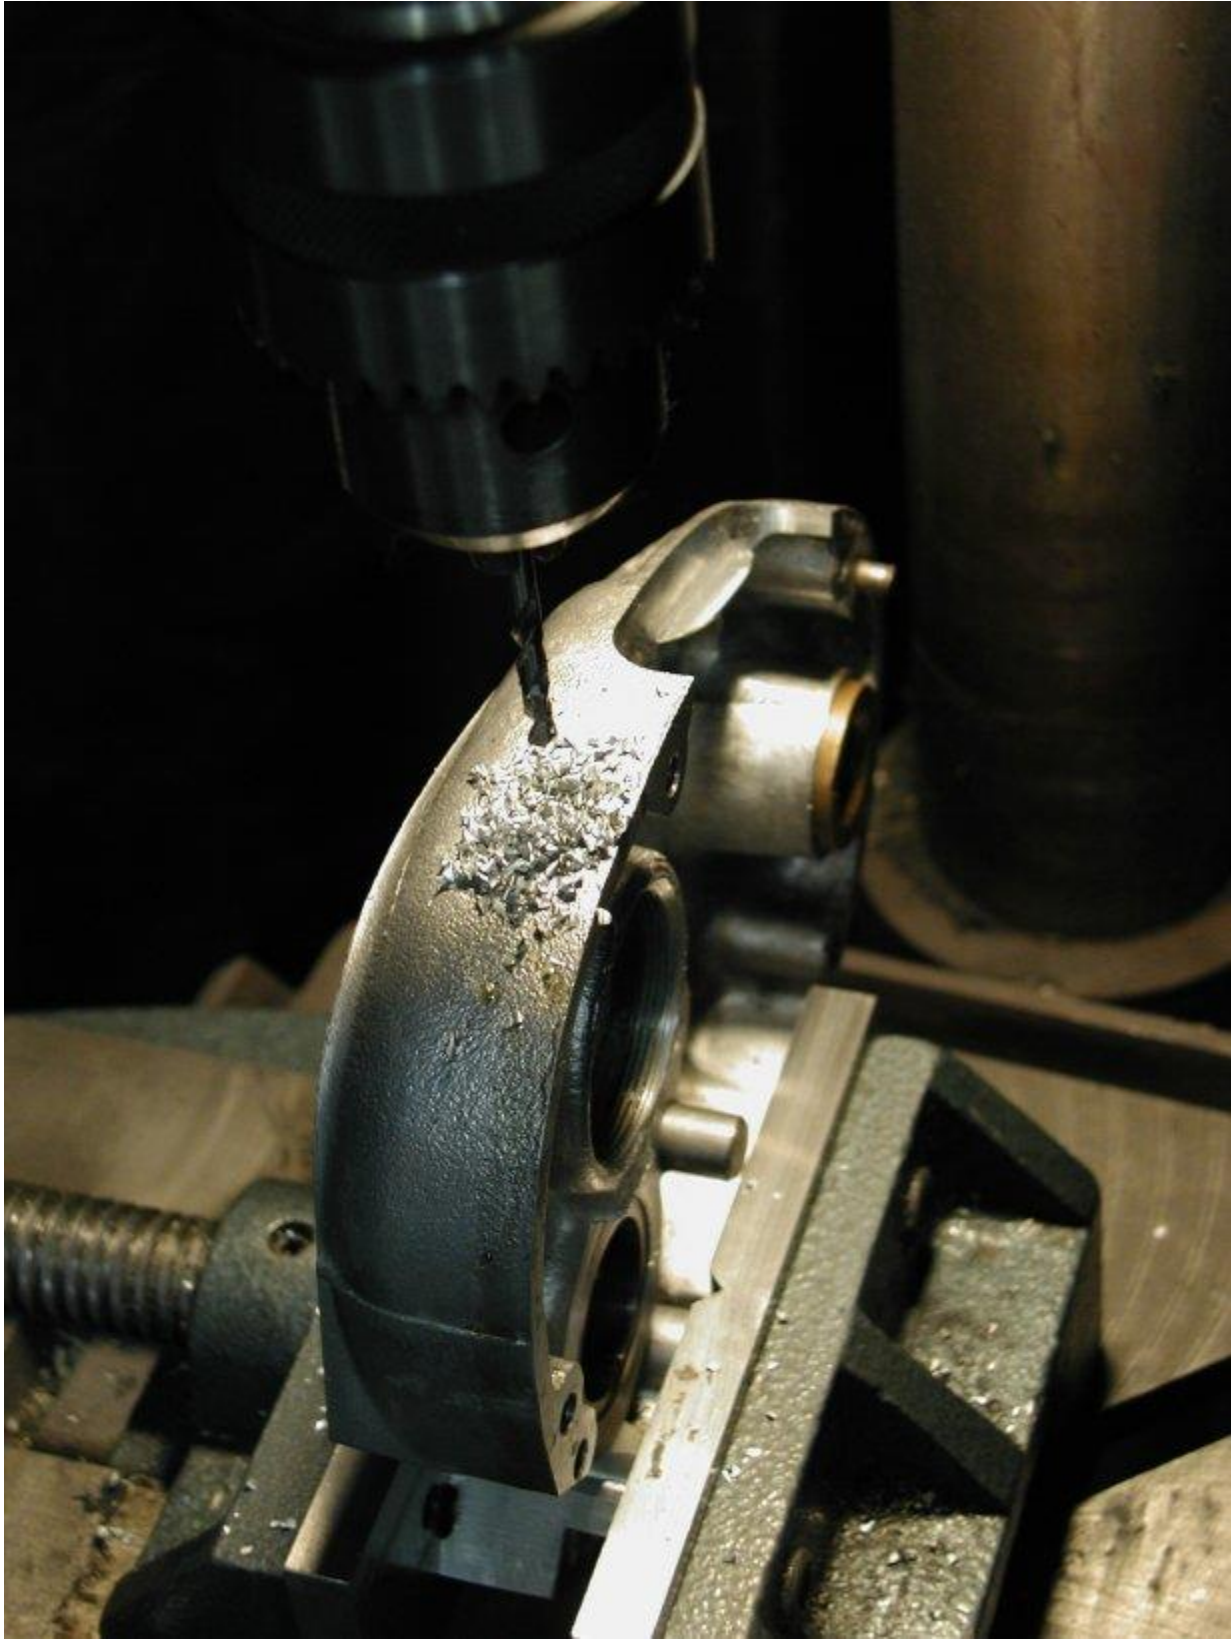
A picture of the breather hole drilled.

Note: the angle of the hole is towards the center of the bearing.

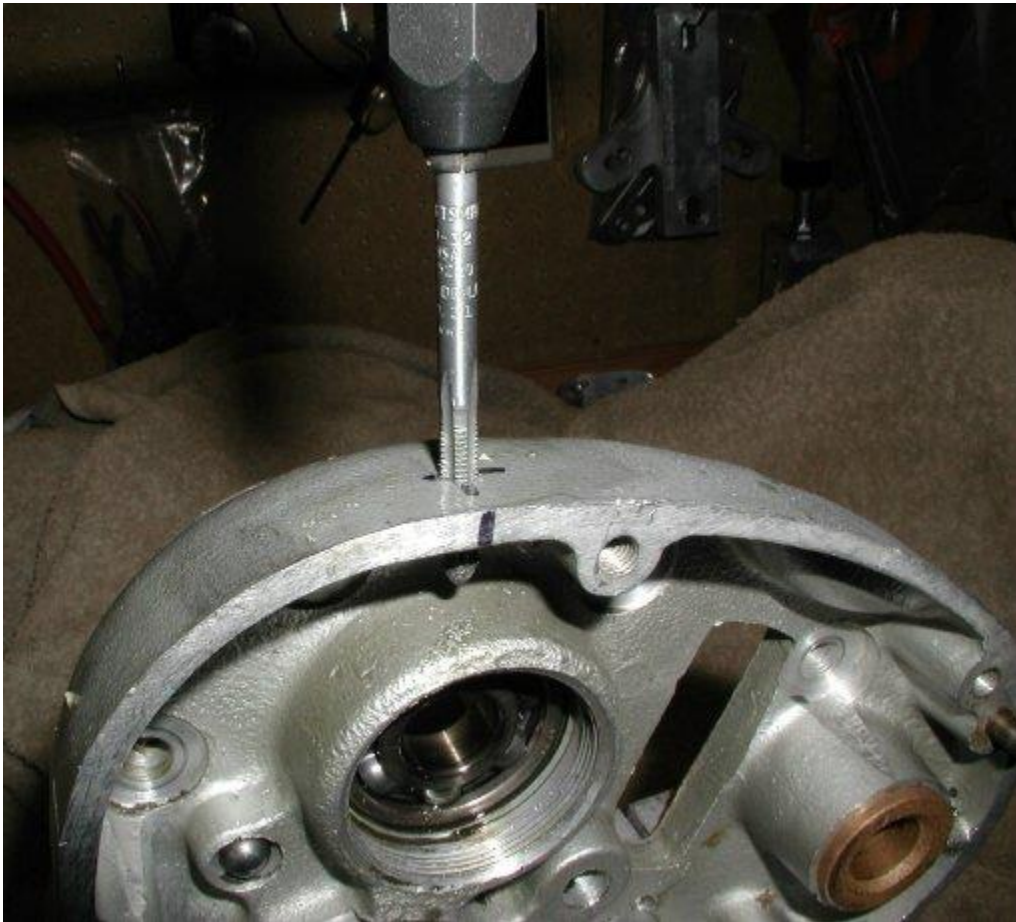
A picture of case being tapped.

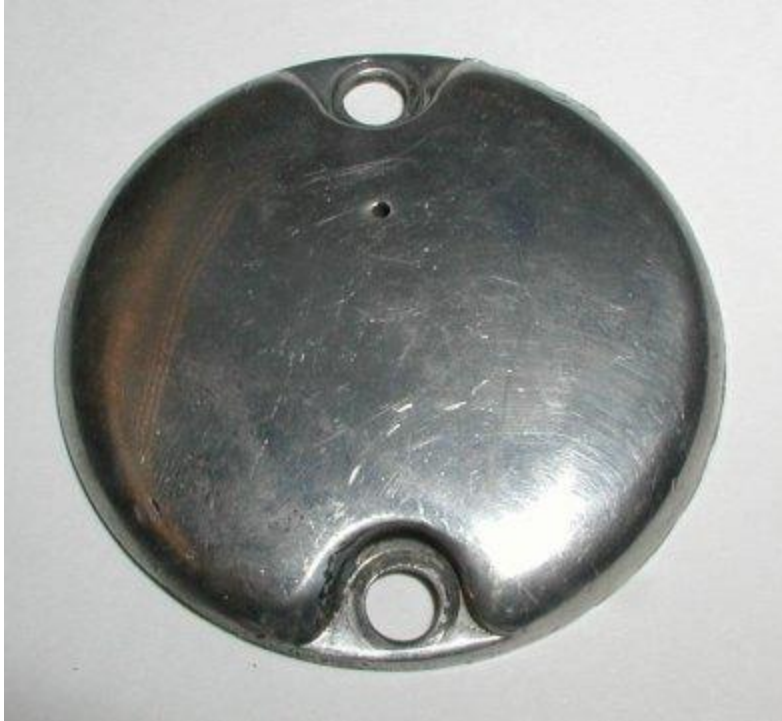
A picture of a hole drilled in the inspection cover.

Another option used by some riders is to drill a small hole in the inspection cover. This hole should be very small like a #58 drill (.042"). Replace the inspection cover with the hole towards the top of the gearbox. This is an easy and cheap fix and safe, for if the cover starts to leak out this hole, a dab of silicone sealer will plug up the hole.
