Eliminating oil leaks due to pressure build up in the Commando gearbox

by Fred Eaton

The Commando gearbox will build up pressure due to heating, and this can cause oil to leak out the seals and through the main shaft bore. This problem was fixed on the MK3, but can be fixed on earlier gearboxes.

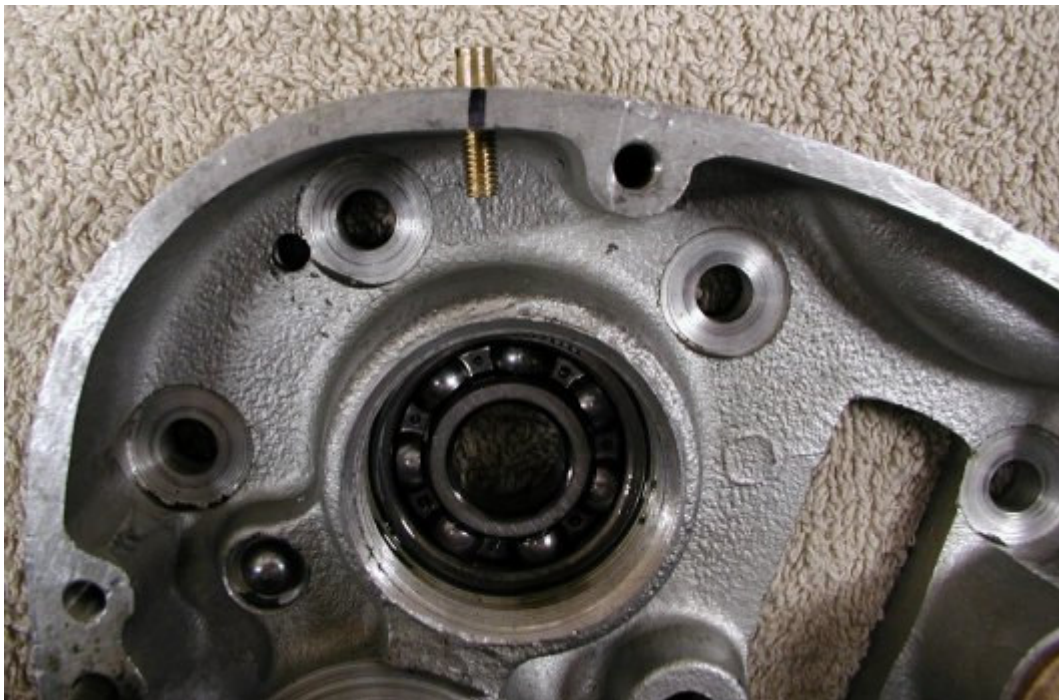
A picture of the breather installed on the inner gearbox case.

The best way to fix the pressure build-up is to install the MK3 breather vent (06-5199). This can easily be done with a #21 drill and a 10 x 32 tap. Drill a #21 hole, in the position shown in the next picture, .8" from the stud hole and 3/8" in from the edge. Tap this hole with a 10 x 32 tap and thread in the breather vent.

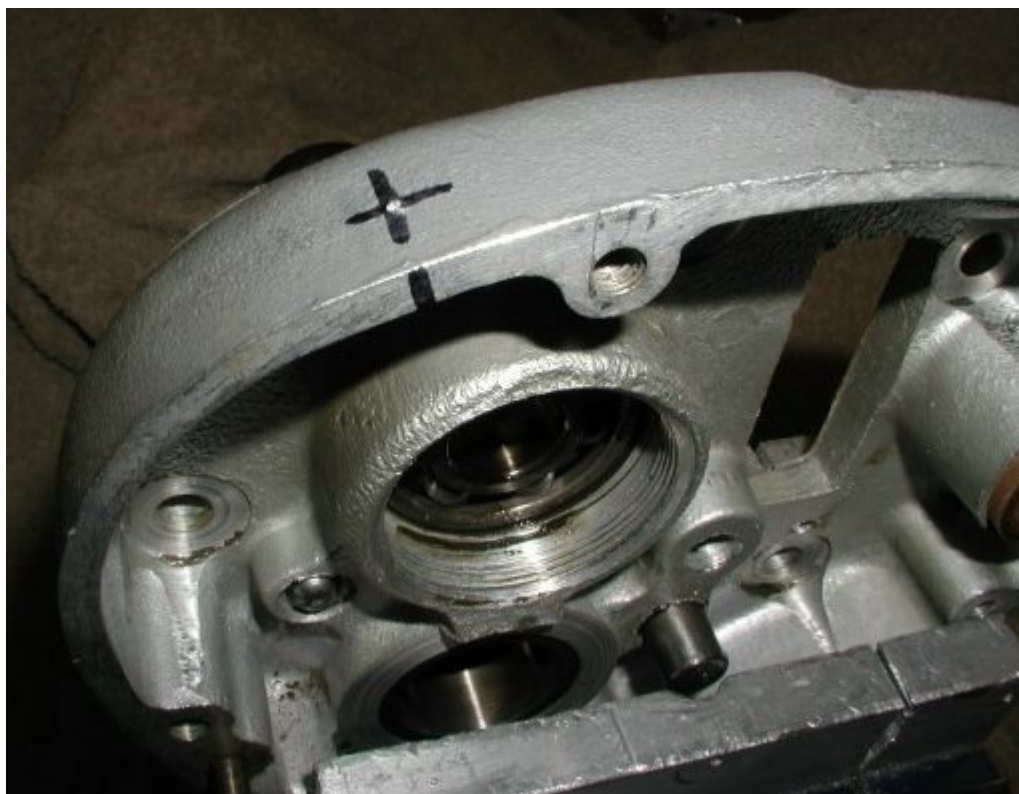
The inner case marked and punched where the hole is to be drilled.

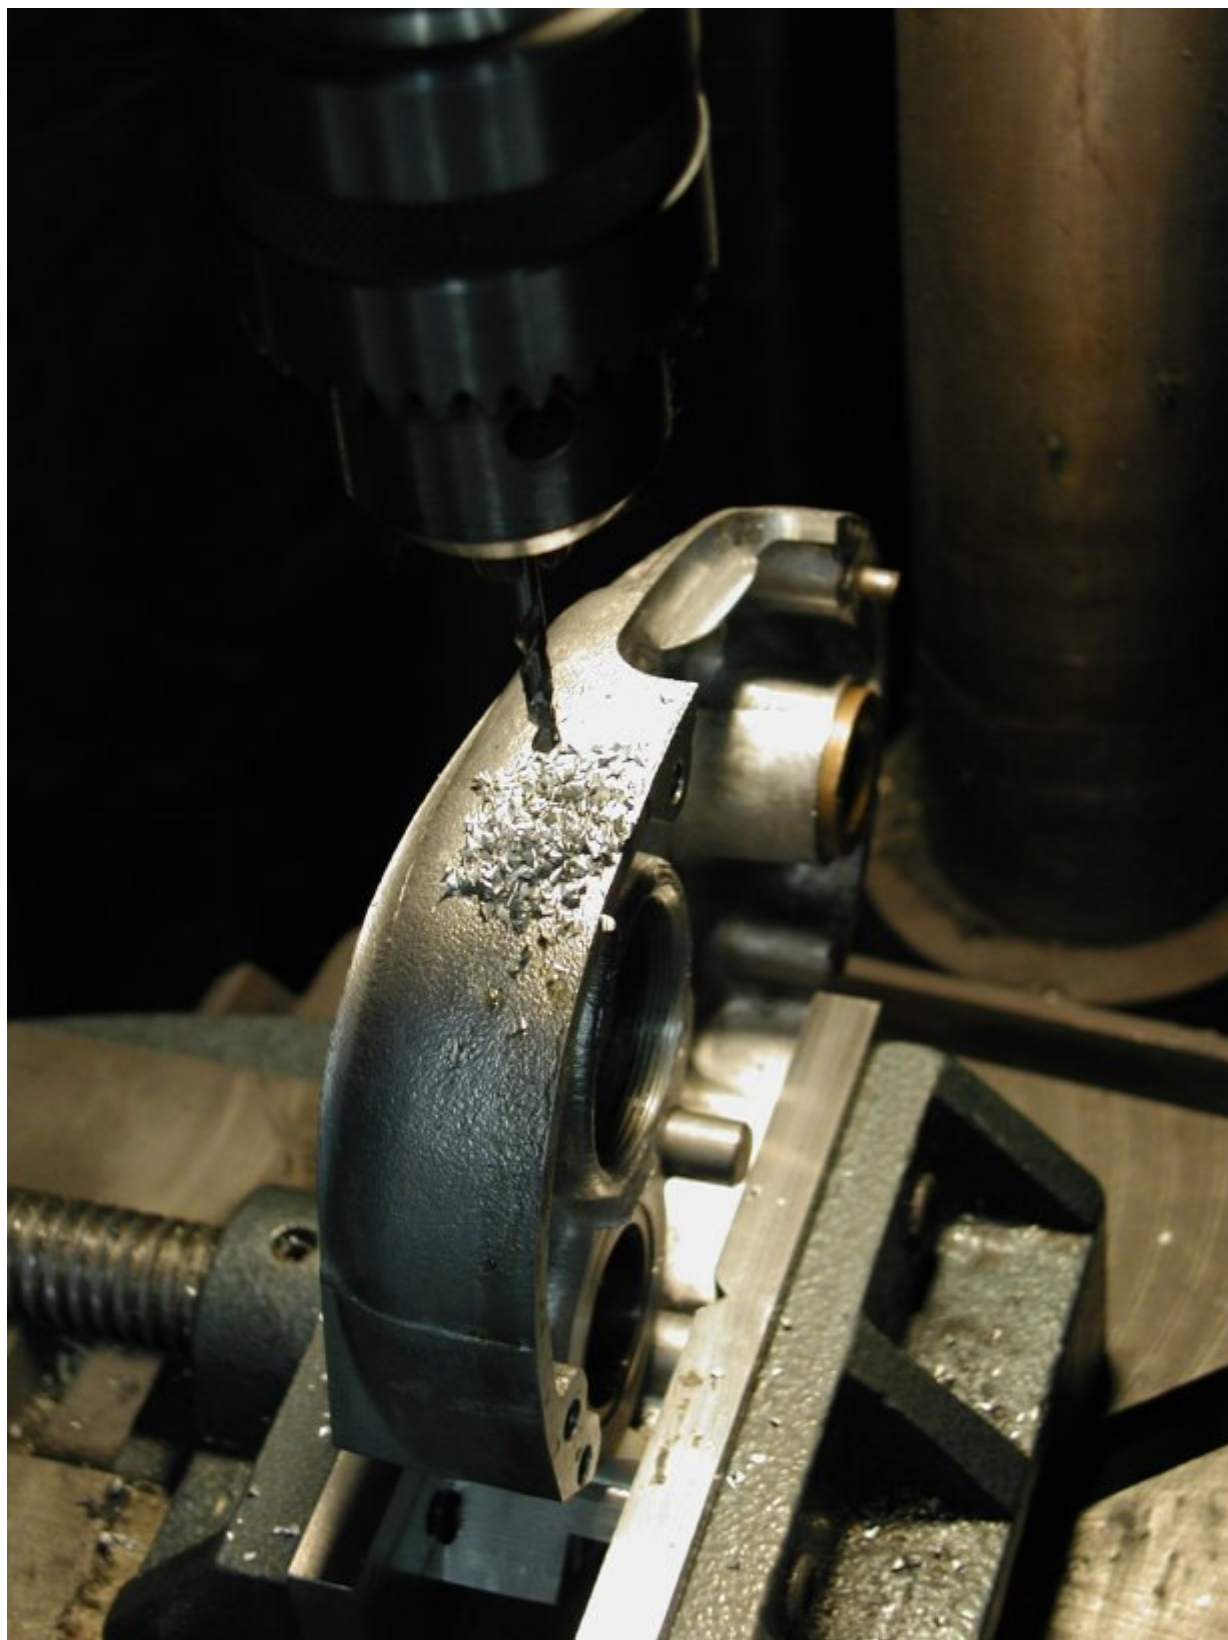
A picture of the breather hole drilled.
Note: the angle of the hole is towards the center of the bearing.

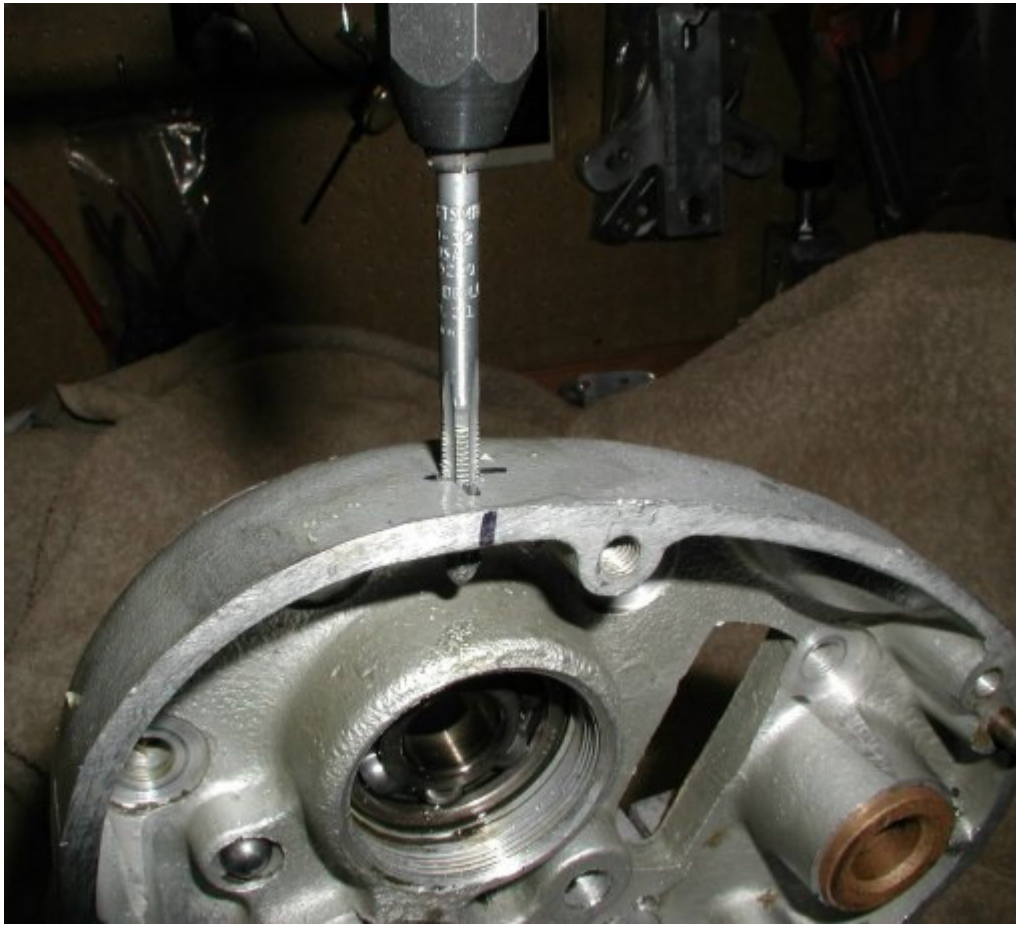
A picture of case being tapped.

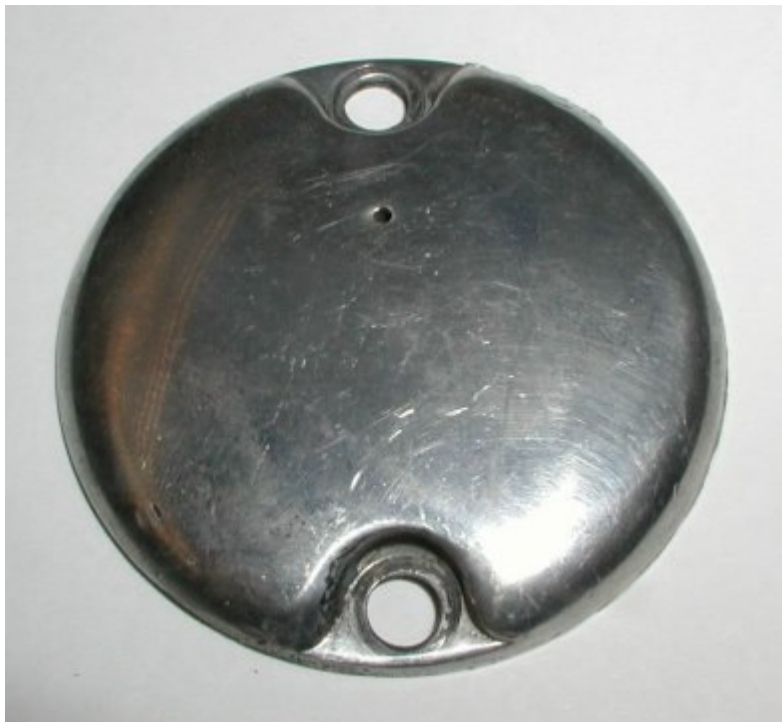
A picture of a hole drilled in the inspection cover.

Another option used by some riders is to drill a small hole in the inspection cover. This hole should be very small like a #58 drill (.042"). Replace the inspection cover with the hole towards the top of the gearbox. This is an easy and cheap fix and safe, for if the cover starts to leak out this hole, a dab of silicone sealer will plug up the hole.
