## GROUP 4:— Crankcases, breathing and main bearings

## GROUPS 5, 6, 7:— Gearbox

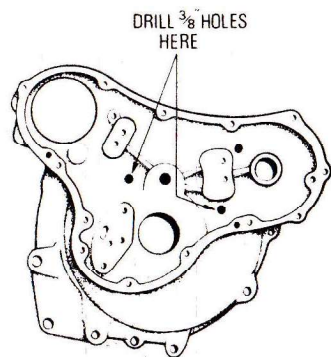
Diagram 4. Timing side crankcase showing holes for 850 breathing. See page 14.

The 830 breather is much better than both earlier systems, but really you need 830 cases to make it work, so that you get good oil return from the sump and a filter, but you can get good results by fitting a pipe of about  $\frac{1}{2}$ in bore into the back of the timing chamber where the magneto used to go (in the days when Lucas ignition systems were guaranteed for two years, including points wear). The pipe should stick through the case about  $\frac{1}{2}$ in and slope downwards, so that oil running down the inside of the case doesn't get carried up the pipe with the air going out. Oil runs down from the inlet valve as well as sloshing about from the timing gear. How you fit the pipe is up to you; you can't just buy the bits and slap them in. It is also necessary to drill holes in the timing side crankcase—try and get a look in an 830 timing cover and copy the size and position and I don't recommend drilling the holes without dismantling the engine; no Malcolm, put that brace and bit down immediately! See Diagram 4, page 12.

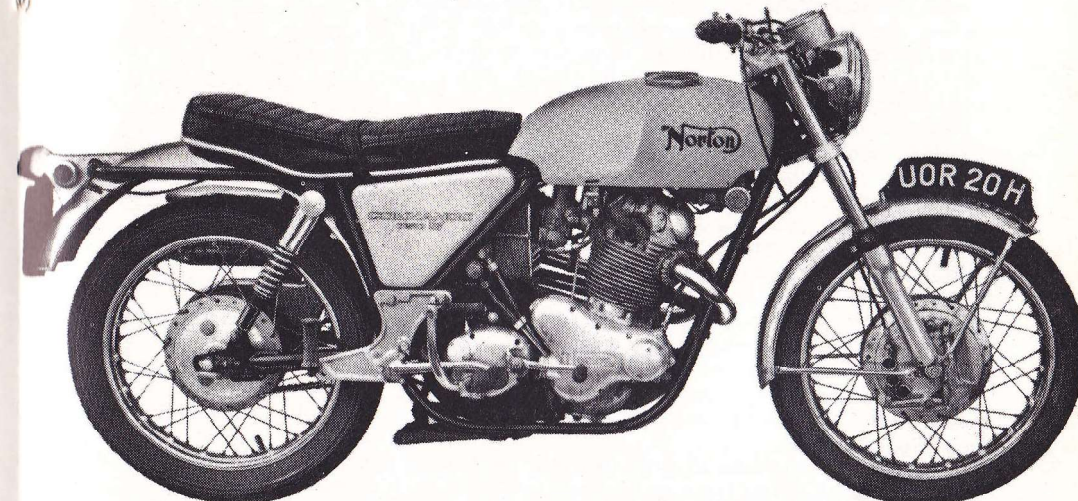
*The 'S' type made for the Americans and one of the faster early models (1970). Note the lack of cush drive rear hub (bolt up as Dommie), and the T.L.S. front brake. Both exhaust pipes up the left side made a beautiful sound.*
